EFFECT OF CABLE CURVATURE ON CABLE POSITION, 5 FT. EXACT DEPTH

DEPTH MEASUREMENT ERRORS NEAR CABLE BEND, 5 FT. CABLE DEPTH

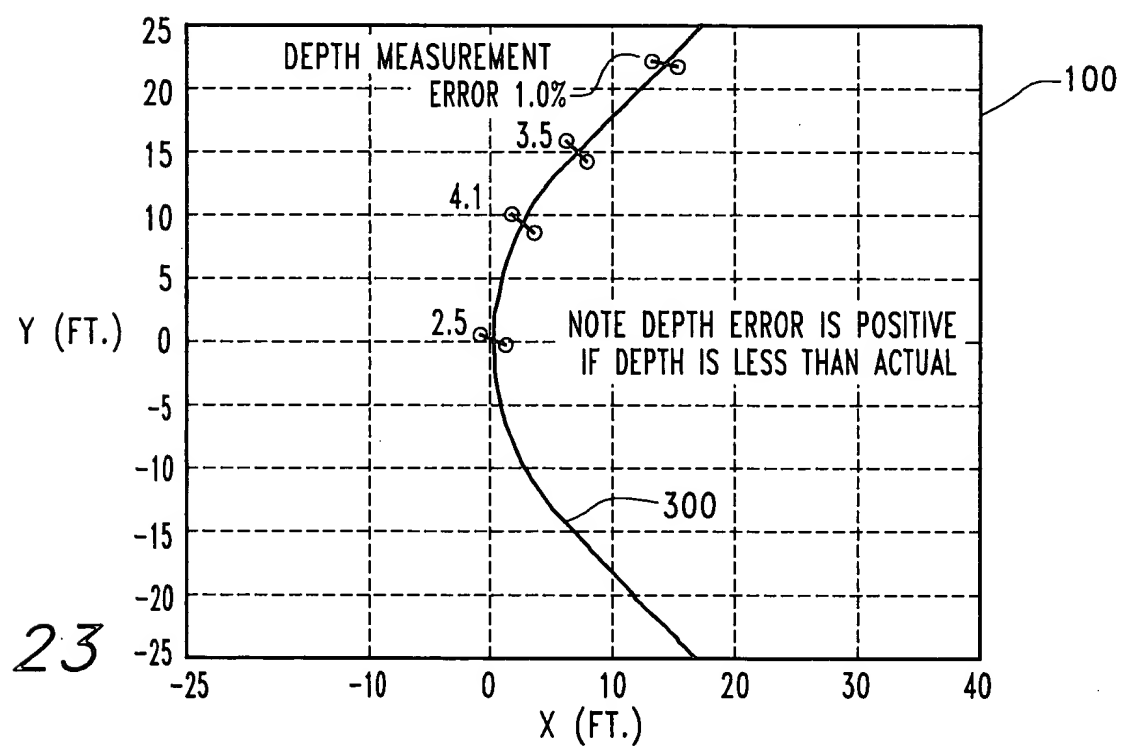
FIG. 23

DEPTH MEASUREMENT ERRORS NEAR CABLE BEND, 5 FT. CABLE DEPTH

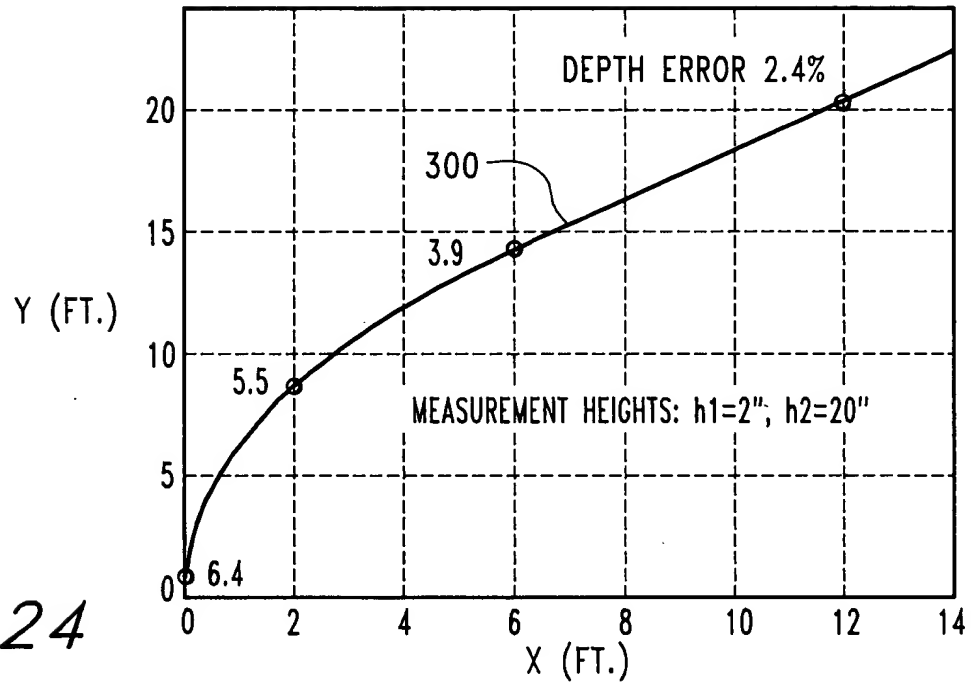
FIG. 24

CABLE DEPTH FROM 2-POINT HEIGHT MEASUREMENTS, 5 FT. DEPTH

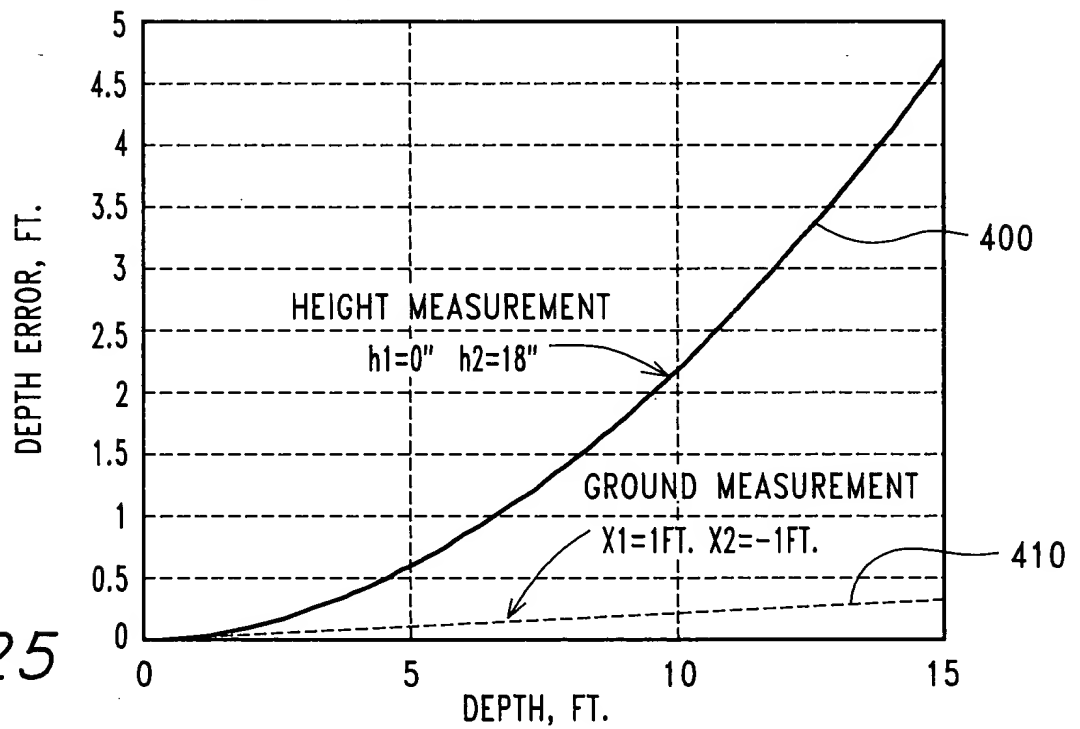
FIG. 25

DEPTH ERROR DUE TO A FLUX MEASUREMENT ERROR OF 2%
